Manhole Inspection Summary

Manhole # **S43GG_008MH**

Insp Date: **10/22/07 12:02 PM**

Location Address: **ELLSWORTH**

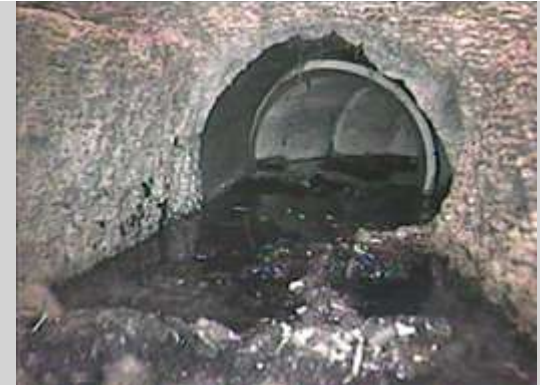
12 O'Clock Outflow

12 in. Circular Gravity Sewer
Pipe Out @ 12 O'Clock

Pipe Height: **8.4** (in.) Rod and Bar
Pipe Material: **Clay** ☐ Pipe Lined
Invert Depth: **9.62** (ft.) Flow Characteristics: **Slow**
Deposits: ☐ None ☐ Mud ☒ **Sludge** ☒ **Debris** ☐ Grease
Silt Depth: **2** (in.) Deposits Extent: **Light**
Infiltration: **None** Pipe Seal Cond: **Sound**

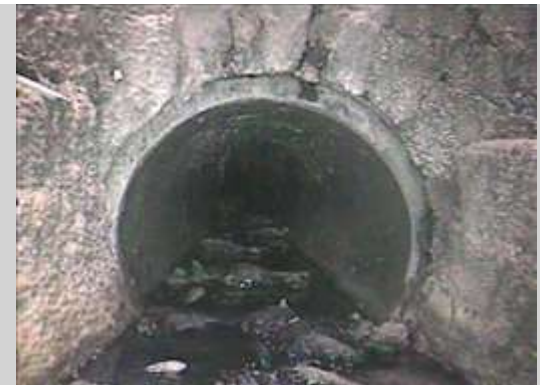
6 O'Clock Inflow

15 in. Circular Gravity Sewer
Pipe In @ 6 O'Clock

Pipe Height: **9.6** (in.) Rod and Bar
Pipe Material: **Clay** ☐ Pipe Lined
Invert Depth: **9.65** (ft.) Flow Characteristics: **Slow**
Deposits: ☐ None ☐ Mud ☒ **Sludge** ☒ **Debris** ☐ Grease
Silt Depth: **2** (in.) Deposits Extent: **Light**
Infiltration: **None** Pipe Seal Cond: **Sound**
